Watts Bar Nuclear Plant, Unit 1
Facility Operating License No. NPF-90
NRC Docket No. 50-390

**Subject: Licensee Event Report 390/2011-004 Revision 1, Reactor/Turbine Trip
due to Loss of Main Generator Excitation**

4. TITLE
Reactor / Turbine Trip due to Loss of Main Generator Excitation

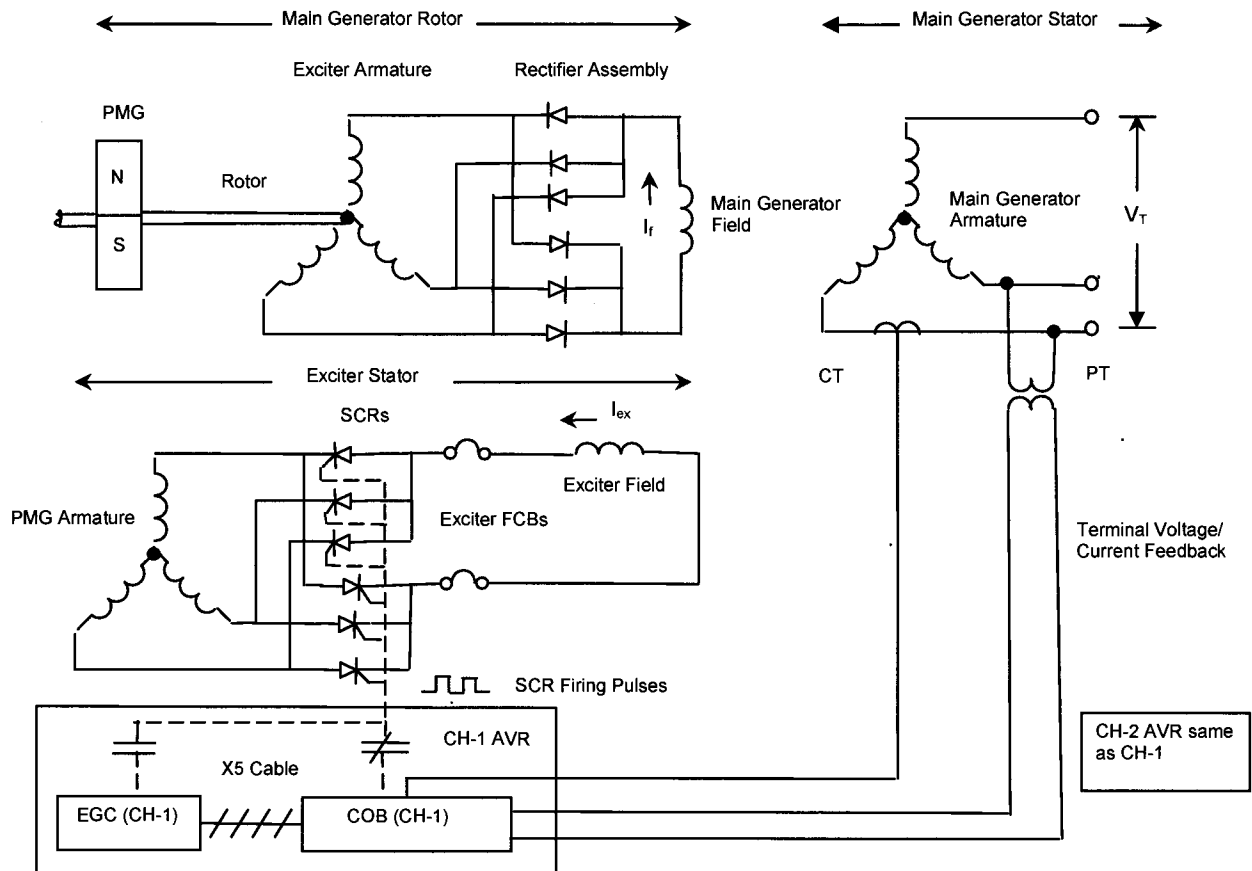
**Figure 1
Simplified Brushless Excitation System Block Diagram**

The major electrical components that make up the main generator excitation system are the AVR, exciter field windings, exciter armature windings, rotating rectifier assembly, and the main generator field windings (see Figure 1). The AVR is a dual-channel digital control system designed by ABB that was installed during U1 Refueling Outage 10, which ended May 21, 2011. Each AVR channel has one Control Board (COB) module and one Extended Gate Controller (EGC).

Testing at ABB Switzerland and ABB Canada facilities indicates that the most probable cause of the loss of excitation was an intermittent fault in the "X5" multi conductor cable that provides signal communication between the EGC and the COB.

During normal COB channel operation in either automatic or manual, the EGC firing pulses are blocked. An intermittent fault in the "X5" multi conductor ribbon cable could cause a spurious signal to be sent to the EGC signaling the EGC to turn on. With the EGC on and no output pulses (pulses blocked), the AVR software will interpret this condition as an EGC fault and open the exciter field breakers. During testing at ABB, a simulated "X5" cable fault replicated the faults and alarms that occurred at WBN on May 29. Other failures replicated some of the alarms or faults experienced, but failure of the "X5" cable was the only tested configuration that produced all the alarms and signals experienced on May 29, 2011.

1. Replace existing "X5" ribbon cable in the next planned or forced outage.
2. Send suspect "X5" ribbon cable to TVA Central Laboratory for failure analysis.
3. Revise TA to place the EGC in service with the field circuit breaker trip function disabled and instrumented for approximately one operating cycle. At the end of the cycle, evaluate for no spurious trip signals and return EGC to full service.
